Manhole Inspection Summary

Manhole # S33E__013MH

Location Address: **300 marion st**

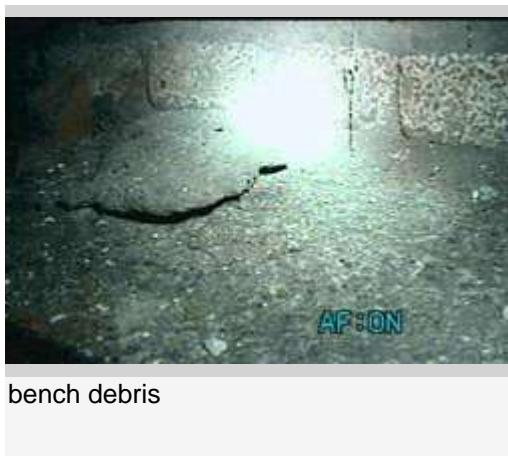
Defect 3

Condition: ☐ Sound ☐ Cracked ☐ Root Intrusion ☐ Deteriorated ☐ Leaks ☒ Debris

bench debris

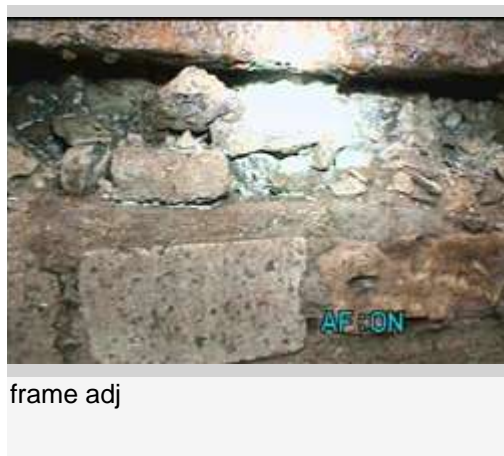
Defect 2

Chimney / Frame Adjustment ☒ Exists Material: **Brick** ☐ Parged Height: **4** (in.)

Condition: ☐ Sound ☐ Cracked ☐ Root Intrusion ☒ Loose Brick ☒ Deteriorated

frame adj

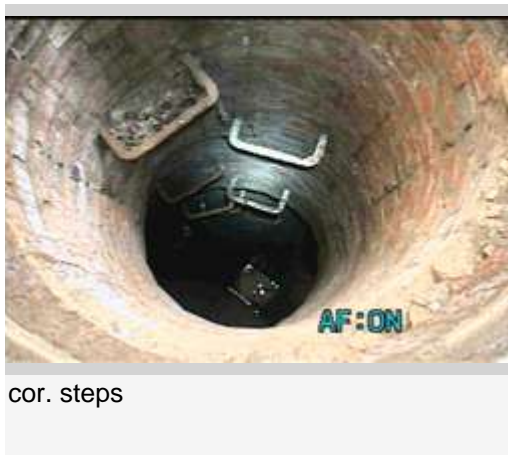
Defect 1

Steps Count: **8** Missing: **0** ☒ Corroded

cor. steps

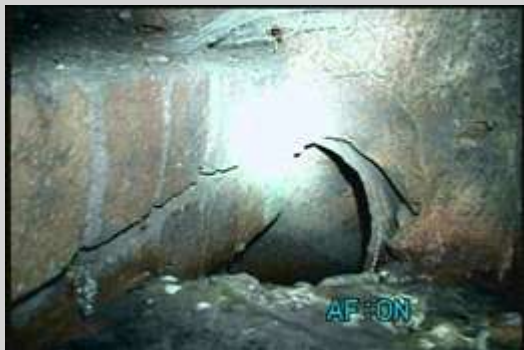
12 O'Clock Outflow

channel makes a sharp drop into the 12
